3.0 L-Bar, New Mexico, Disposal Site

3.1 Compliance Summary

The L-Bar, New Mexico, Uranium Mill Tailings Radiation Control Act (UMTRCA) Title II Disposal Site was inspected on August 26, 2008. The tailings impoundment is in good condition. Erosion is active in several areas of the site associated with the diversion channels, and repairs are scheduled for 2009 to prevent an impact on the integrity and function of the tailings impoundment and diversion structures. Site maintenance activities conducted during the past year included installation of new sections of barbed-wire fence to accommodate grazing and to isolate erosion areas, installing caution signs at the sediment trap and East Channel, and treating tamarisk plants with herbicide. Groundwater monitoring results indicate that all compliance requirements continue to be met. Erosion and vegetation measurements to monitor the condition of the impoundment cover indicate that no erosion is occurring and, overall, the foliar cover of the vegetation is increasing. No cause for a follow-up inspection was identified.

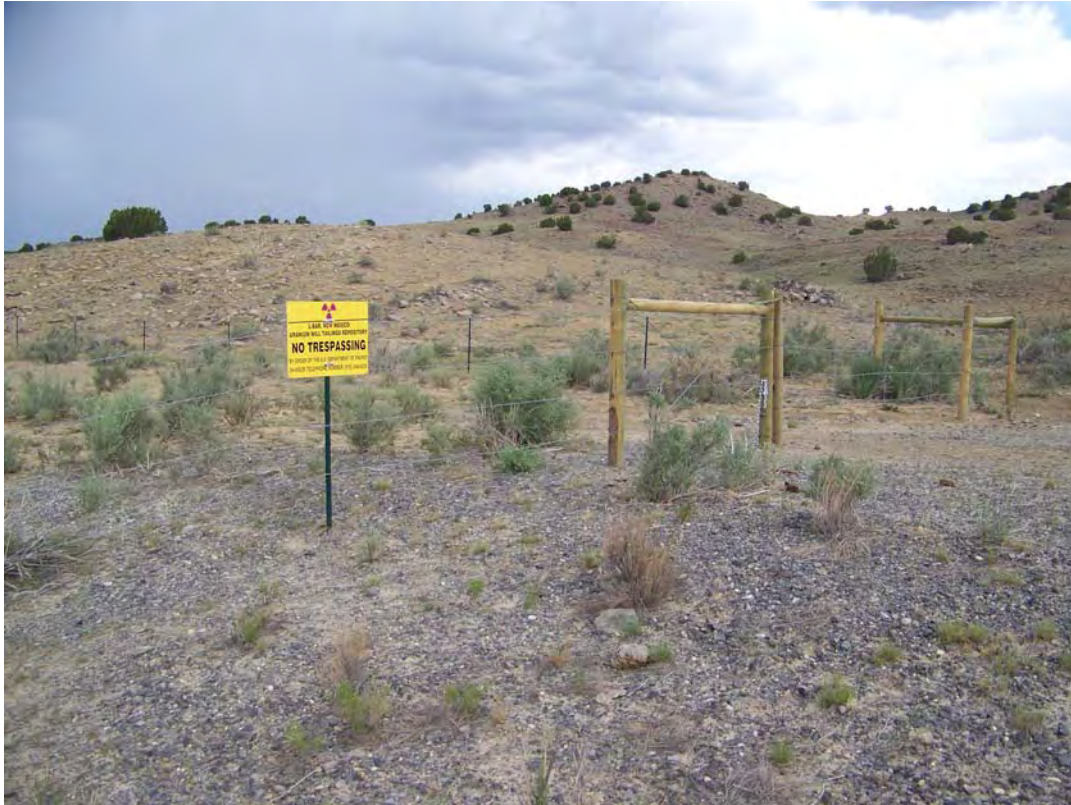
- 3A Land Grant ranchers will maintain these sections. Another 3,000-foot section was installed in the southeast portion of the site to enclose an erosional area that it scheduled to be repaired in 2009. This fence has two wire gates (PL–1) and one metal personnel gate (PL–2). This section will be maintained by DOE and kept in service at least until the repaired area has successfully revegetated.

- 3B Thirty-one perimeter warning/no trespassing signs are attached to the barbed-wire fence at approximately 500-foot intervals. The perimeter signs were in excellent condition. Perimeter signs also were installed near the three gates on the new fence in the southeast portion of the site.

BAR 8/2008. PL-1. New perimeter sign P31 at the southeast wire gate of the new fence.

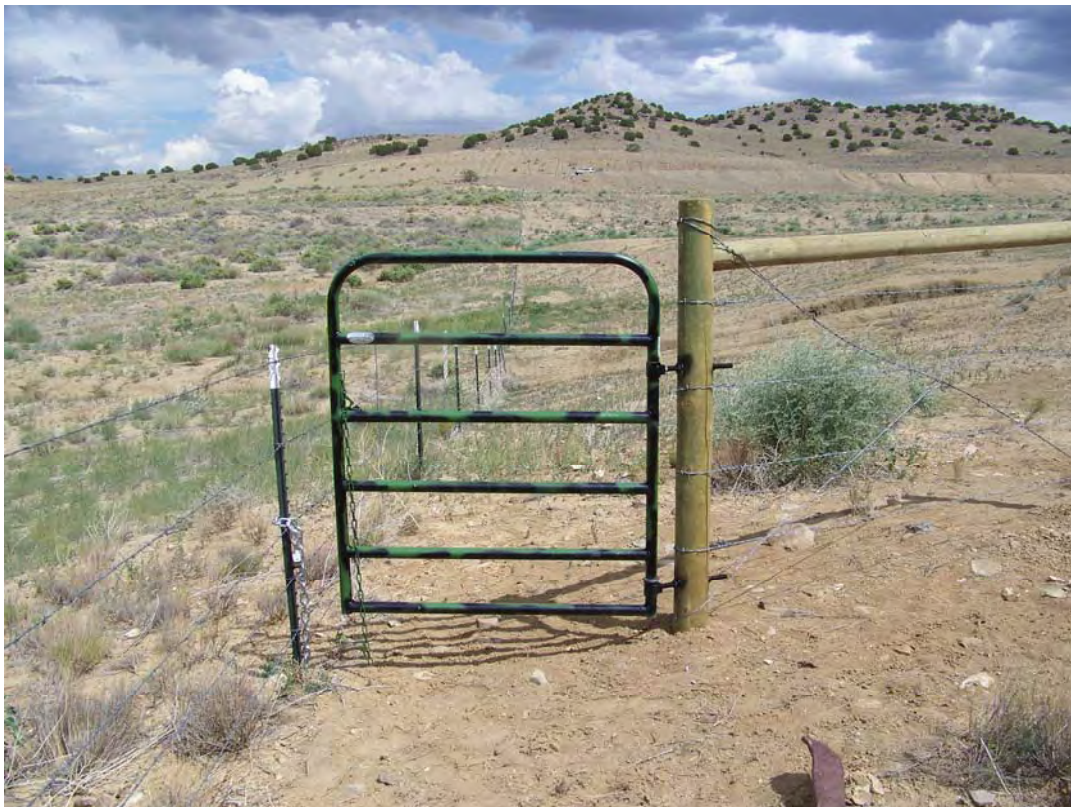
BAR 8/2008. PL-2. Personnel gate at the northwest corner of the new fence.

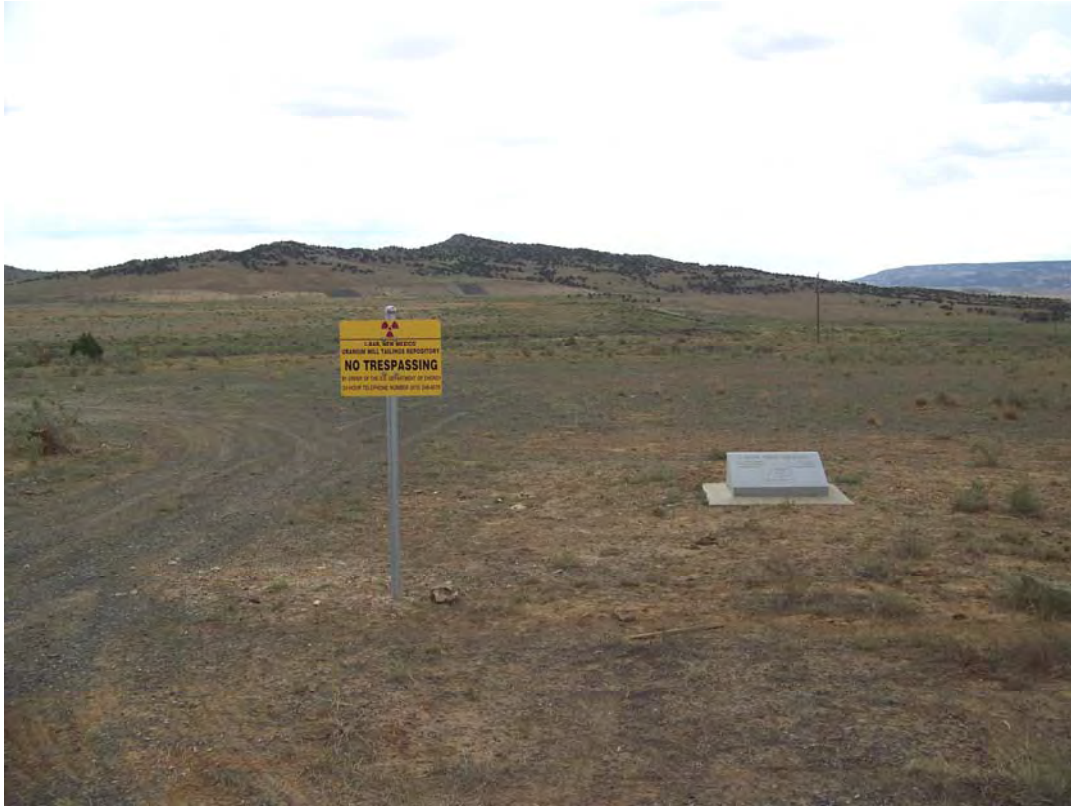
Entrance signs installed on metal posts are located at three access points to the site (PL–3).

Site Markers and Boundary Monuments—The granite site marker, located north of the disposal cell adjacent to the site access road (PL–3), was in excellent condition. Metal t-posts were installed after the 2005 inspection to help inspectors find the eight flush-mounted boundary monuments; the monuments were not checked in 2008.

BAR 8/2008. PL-3. Entrance sign E1 and site marker.

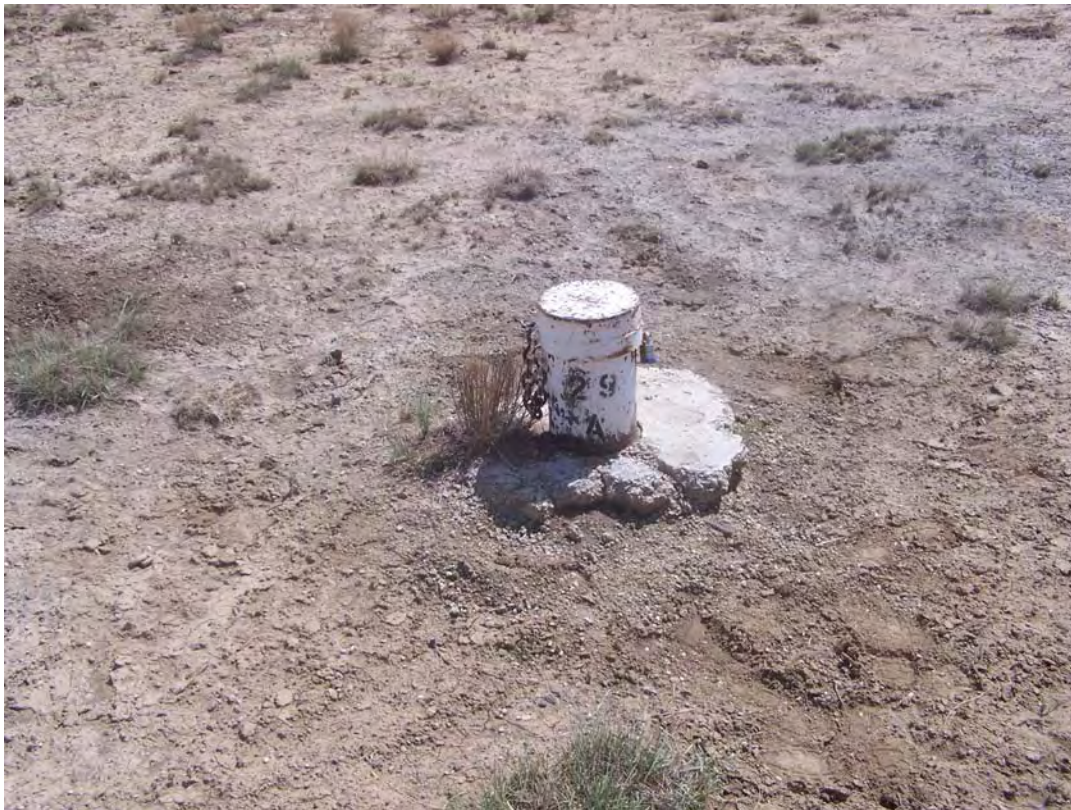
Monitor Wells—The site groundwater-monitoring network consists of ten wells. Nine of the wells are located on the DOE site; background monitor well MW-29A is located outside the northeast corner of the site. The concrete pads of several of the wells have deteriorated and will be repaired (PL-4). A wooden stile was installed after the 2007 inspection to allow samplers to safely cross the fence to access monitor well MW-69 (PL-5). Some well locations do not have established access roads or tracks but are accessible by 4-wheel-drive vehicle as long as the ground is dry.

BAR 8/2008. PL-4. Cracked concrete of well MW-29A pad.

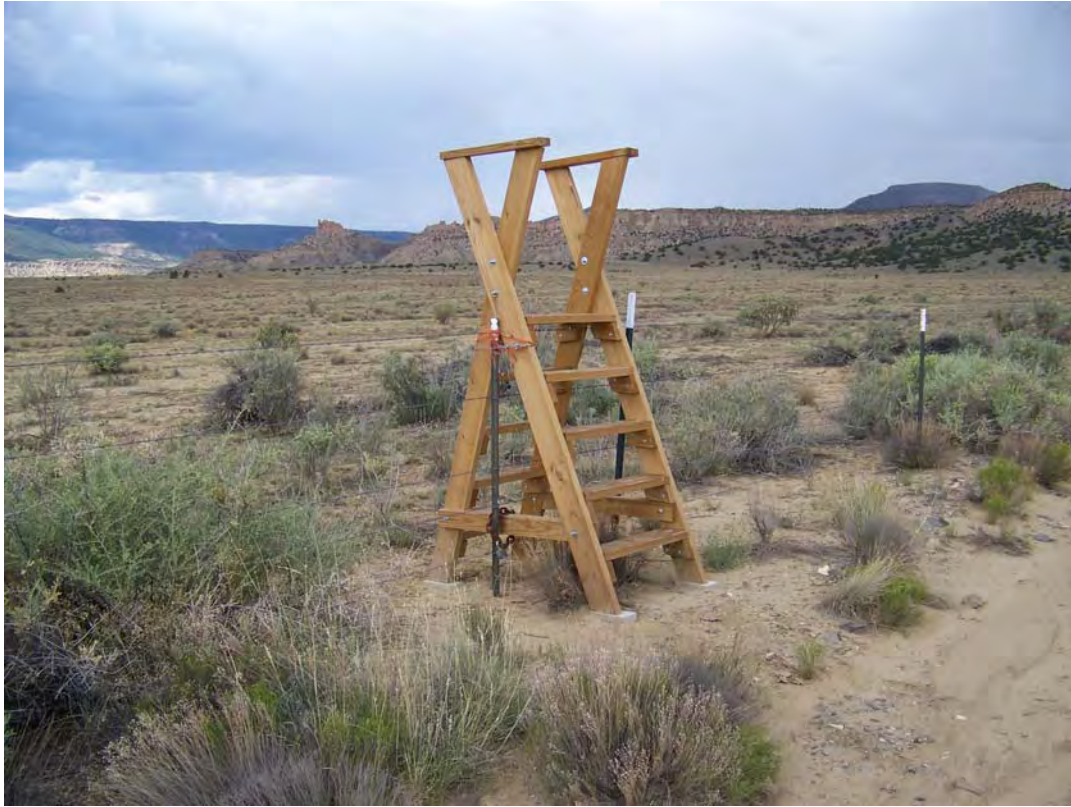
BAR 8/2008. PL-5. Stile to cross fence at monitor well MW-69.

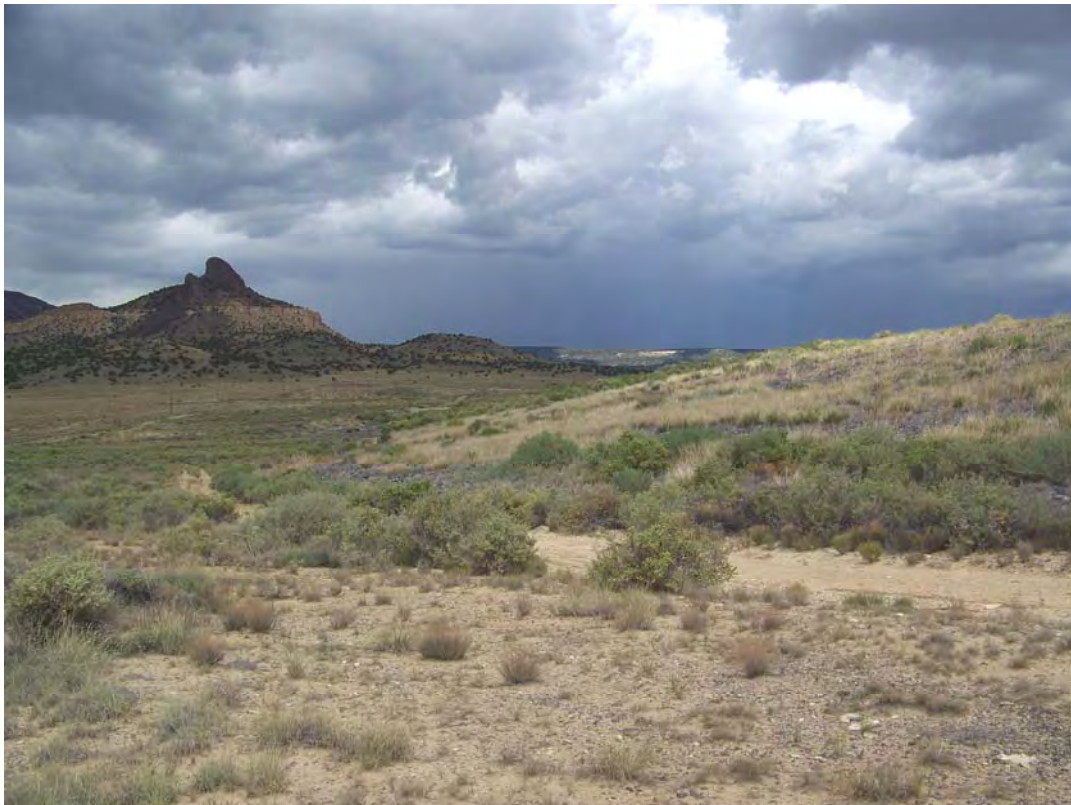
Containment Dam—The tailings impoundment was constructed by damming the upper portion of a natural drainage basin. The face of the earthen containment dam has a 20 percent slope and is rock-armored to prevent erosion and degradation. Native vegetation is encroaching on the face, which is desirable for increasing the erosion protection of the surface (PL-6). There were

no indications of erosion, settlement, seepage, or other modifying processes that might affect the integrity of the dam.

BAR 8/2008. PL-6. View north along the tailings impoundment dam showing encroachment of native vegetation.

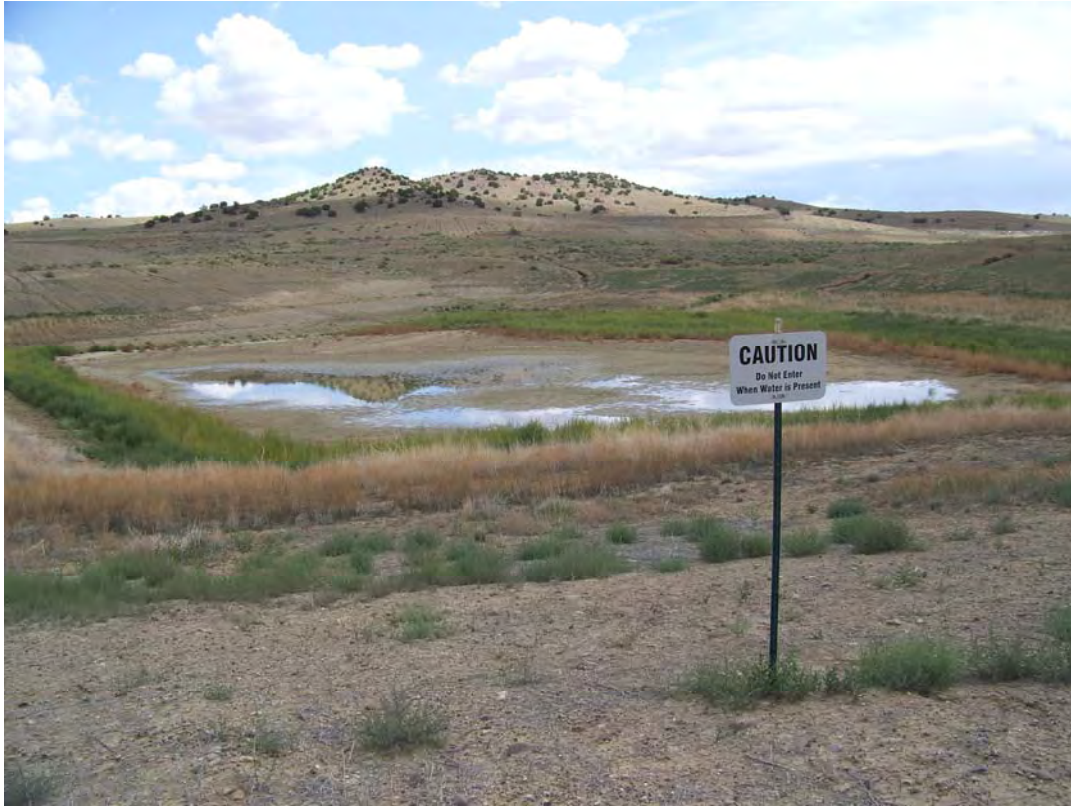
3D Runoff from the watershed upgradient of the tailings impoundment is designed to be conveyed away from the site to a northeastward-flowing drainage via the East Channel. The East Channel is separated from the impoundment by a riprap-armored dike. A tributary channel, the G3 Channel, was constructed to divert runoff from a smaller watershed into the East Channel. Standing water was present in the sediment trap; however, the East Channel was dry at the time of the inspection. Caution signs to identify water hazards at the sediment trap and the East Channel were installed during spring 2008 (PL-7).

BAR 8/2008. PL-7. Sediment trap and caution sign.

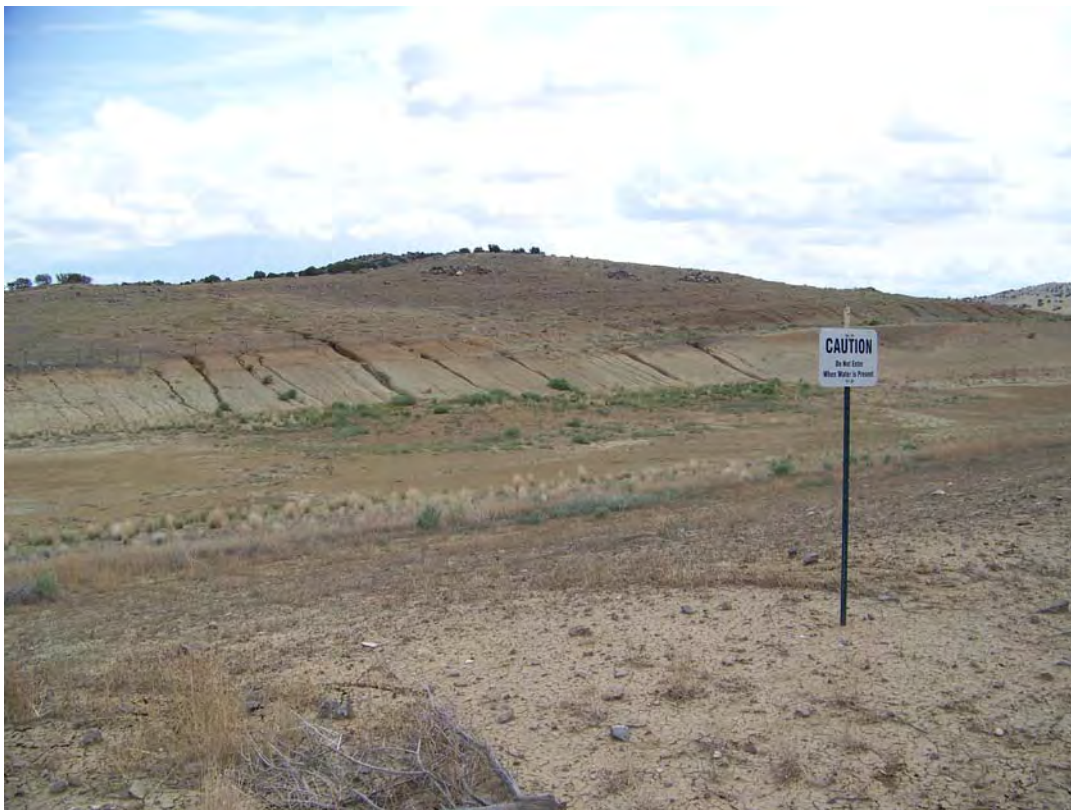
3F Significant erosion is occurring along the east slope of the East Channel (PL-8). Repairs of this area are planned for 2009.

BAR 8/2008. PL-8. East channel and caution sign; gullies on east slope.

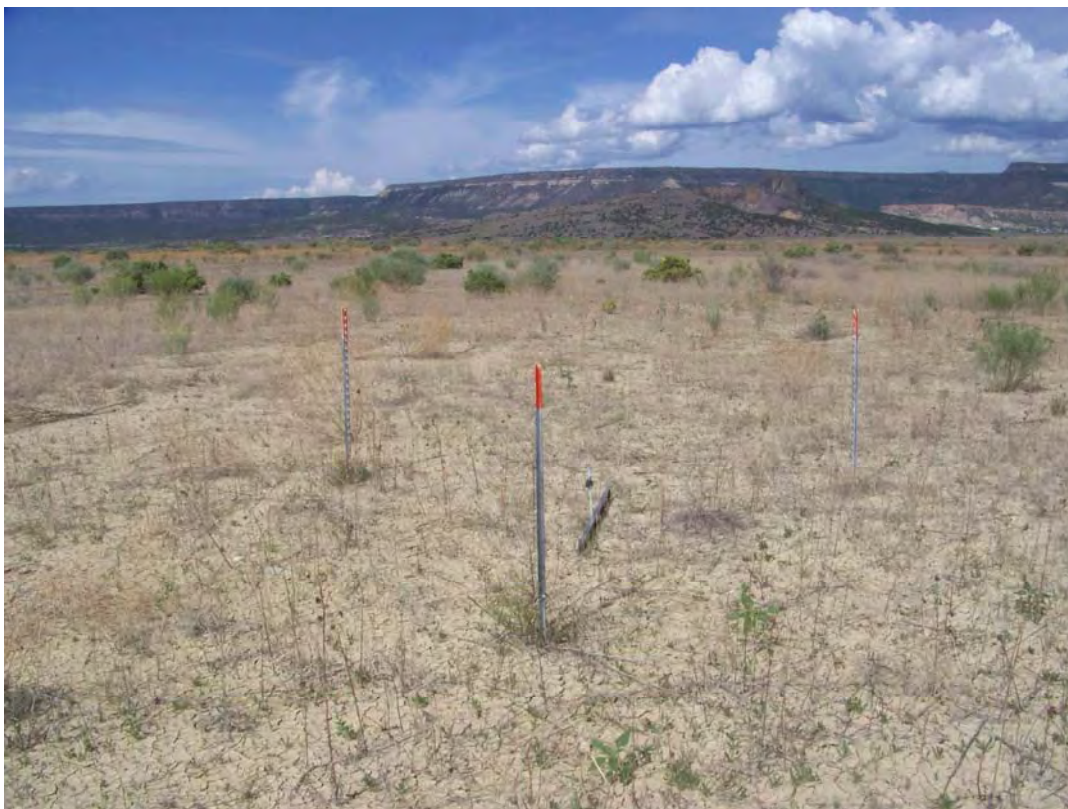
Erosion measurement is accomplished by placing a 4-foot-long level centered at the base of the rebar such that the east end of the level points to the easternmost t-post (PL–9). The height of the rebar is measured from the base of the level to the top of the rebar and is recorded to the nearest 1/16-inch, in accordance with the method established during baseline measurements in 2003.

BAR 8/2008. PL-9. Erosion monitoring point and vegetation plot D2.

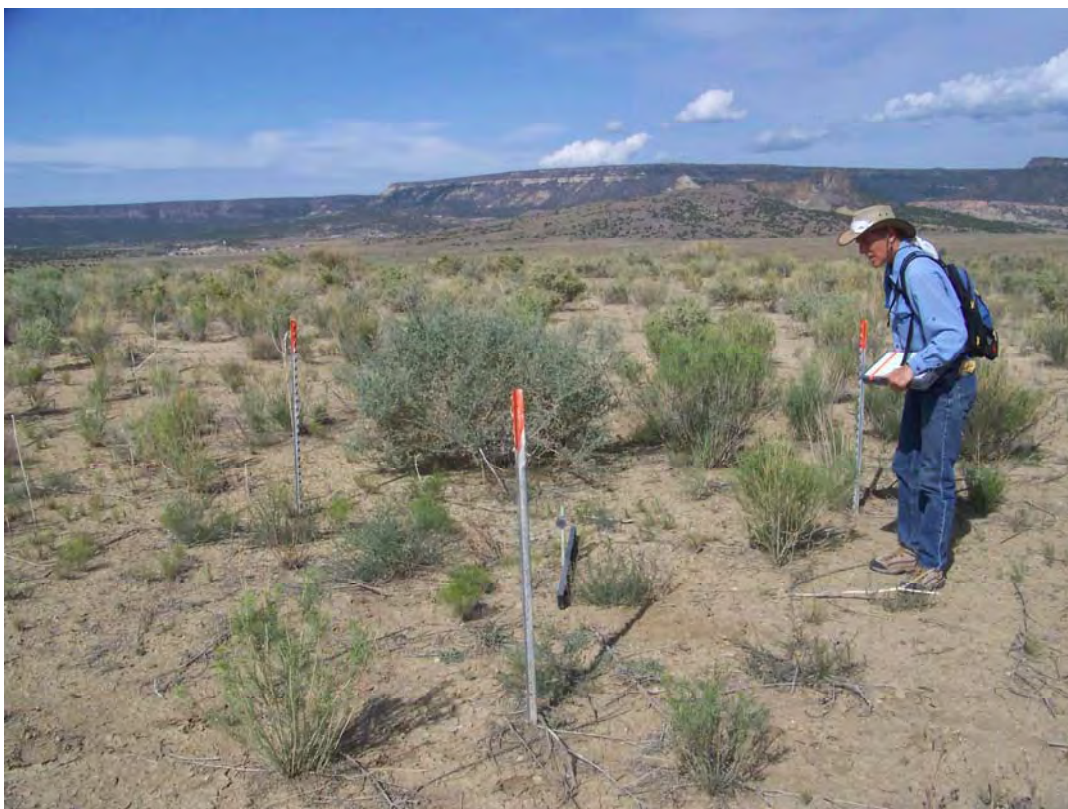
Vegetation types, percentage of foliar cover, litter (organic detritus often consisting of dead annual plants), rock, and bare ground were recorded at each monitoring location (PL-10). Annual or biennial plant species noted at the plots during the 2008 monitoring event included kochia, Russian thistle, annual sunflower, curly-cup gumweed, spotted spurge, and southern goldeneye. Perennial plant species included Nelson's globemallow, silverleaf nightshade, bottlebrush squirreltail, sand dropseed, galleta grass, broom snakeweed, rubber rabbitbrush, and four-wing saltbush.

BAR 8/2008. PL-10. Erosion monitoring point and vegetation plot E1.
